FIELD SERVICE BULLETIN

UPDATE

Navitas Steel Chassis Throttle Inspection and Adjustment

28 April 2022

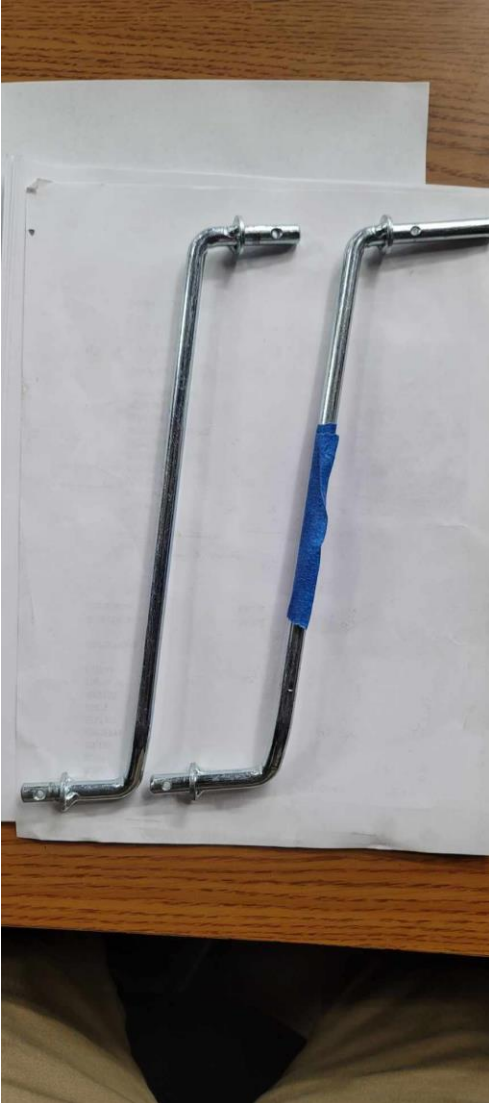
The first part of the inspection process will be to verify if the chassis has the correct throttle rod.

In the picture to the left, the rod on the left is the incorrect rod. This rod was shipped on chassis from January, 1 2022 to April, 30th 2022. Note the short bend.

The rod on the right is the replacement rod that was sent to dealers to replace the incorrect rod. Note the long bend.

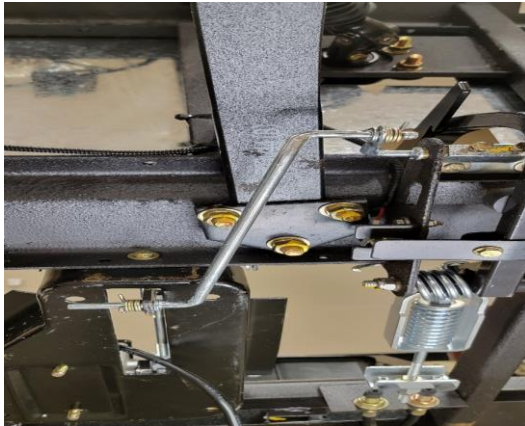
#1 verify pedal arm position at full rest pedal up

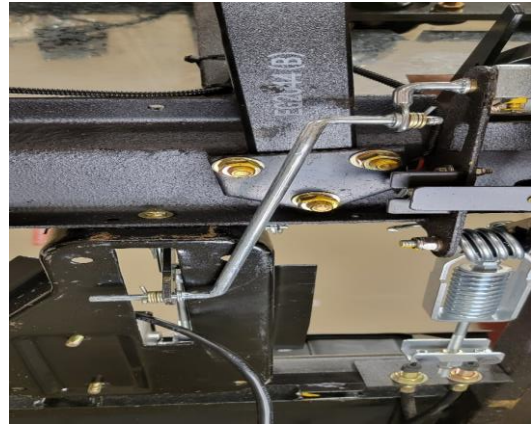
#2 push pedal to floor and verify position of arm

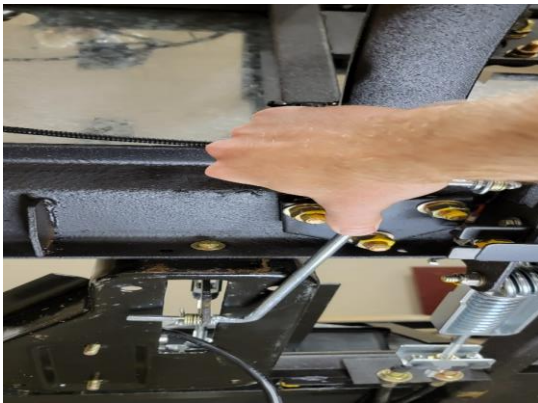
#3 push on arm when pedal is fully depressed and verify if arm will over cam and push against leaf spring.

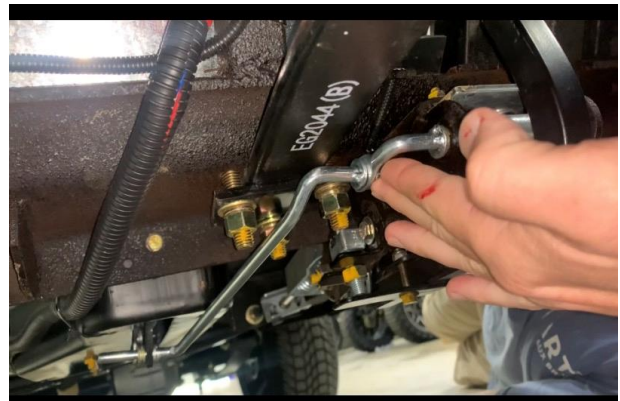
#4 verify if arm is locked against the leaf spring causing throttle pedal to remain fully engaged.

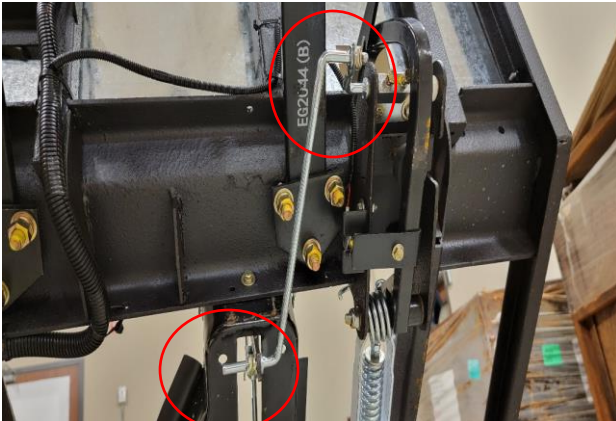
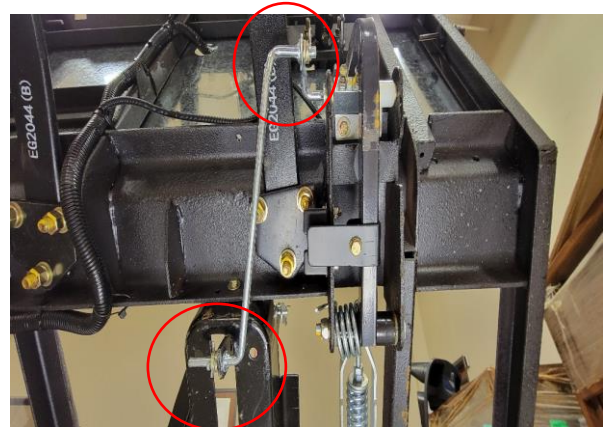
INCORRECT

The throttle rod installed on the chassis from January, 1 2022 – April, 30 2022 needs to be replaced with a new rod. The incorrect rod will be short on both ends, as indicated by the circled areas in the above pictures. The correct replacement rod will be long bend on one end and short bend on the other, as indicated in the pictures below

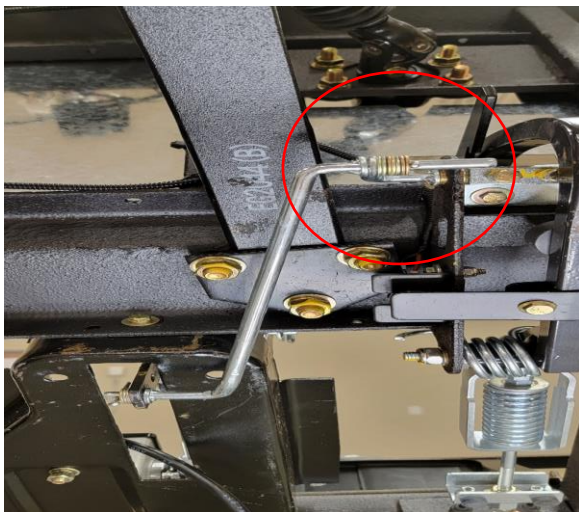
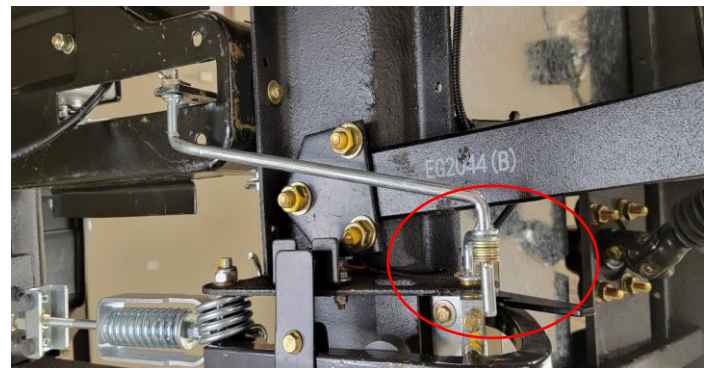
CORRECT

The photos indicate correctly installed replacement throttle rods

Note: you need to install as many washers as possible on both ends of the rod as possible and still allow the installation of the cotter pin. The washers are a as needed shim to remove any free play in the rod.

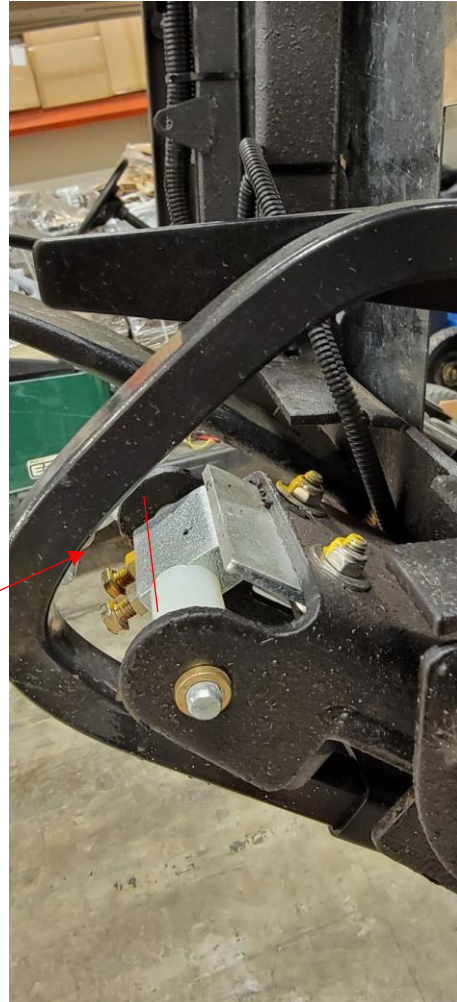
It has been reported that on some units the width of the frame that holds the shaft and kickoff bracket is too narrow, causing binding and not allowing free movement of the kick off bracket, this in turn can cause the throttle to stick as well. Verify free movement of assembly when you have the rod disconnected. If it is stiff or binding then widen the bracket by no more than a few thousandths of an inch until the mechanism moves freely. Spreading can be done various ways, hammer and punch, pry device.
