FIELD SERVICE BULLETIN

UPDATE

Navitas Steel Chassis Throttle Inspection and Adjustment

28 April 2022

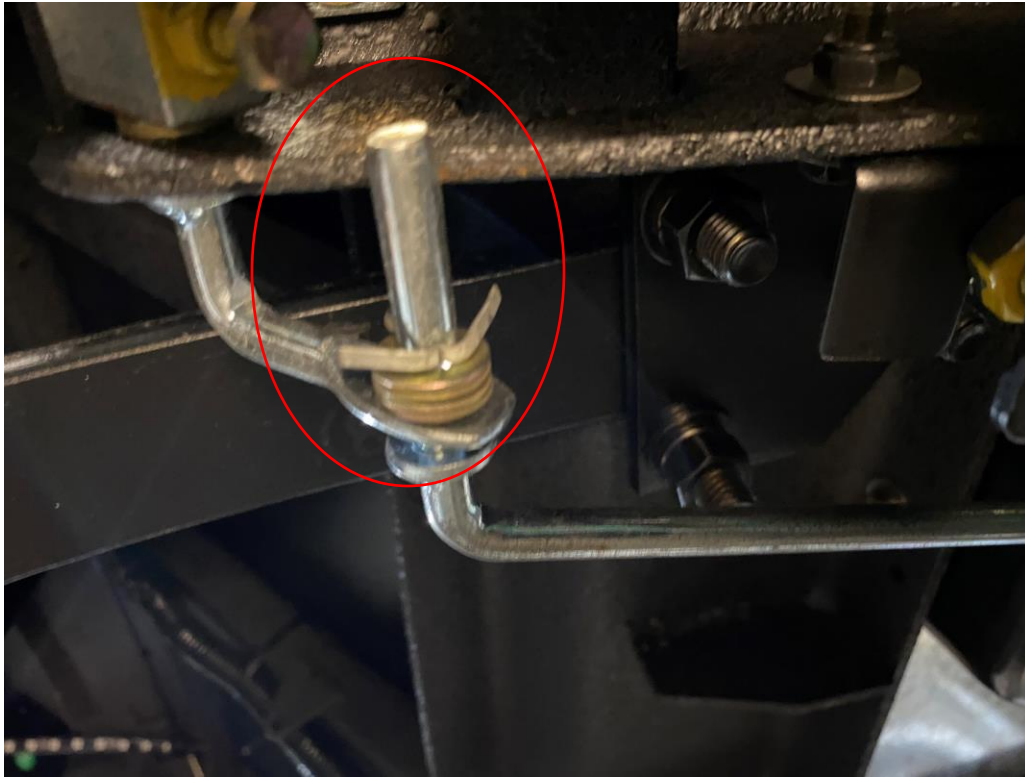
It has been reported that on some units the width of the frame that holds the shaft and kickoff bracket is too narrow, causing binding and not allowing free movement of the kick off bracket, this in turn can cause the throttle to stick as well. Verify free movement of assembly when you have the rod disconnected. If it is stiff or binding then widen the bracket by no more than a few thousandths of an inch until the mechanism moves freely. Spreading can be done various ways, hammer and punch, pry device.
